UNIVERSITY OF PUERTO RICO  
CENTRAL ADMINISTRATION  
NOTICE OF REQUEST FOR PROPOSAL RFP #DRO 24-001-3  
DESIGN AND SUPERVISION SERVICES

**DESIGN AND SUPERVISION SERVICES for  
Project Number: 008227-08264-DRO-D01-RUM**

Project Title: Reconditioning of 15 buildings and structures at  
the University of Puerto Rico Mayaguez Campus

RFP #DRO 24-001-3 / 08227 - 08264

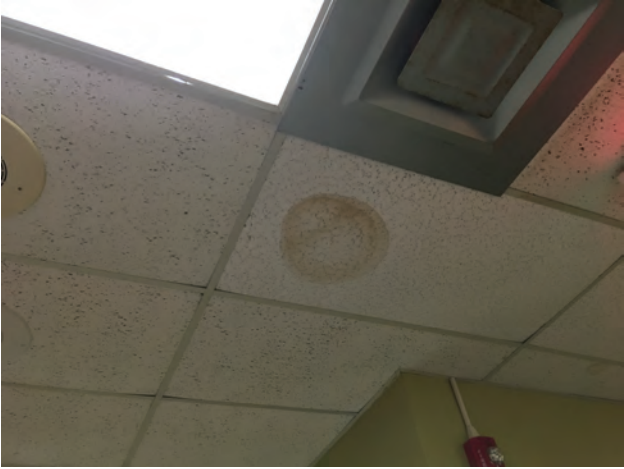
**Photo#** 8

**Damage Description:** Acoustic tile ceiling damage stained and sagging. Several small water stains in several rooms throughout the building.

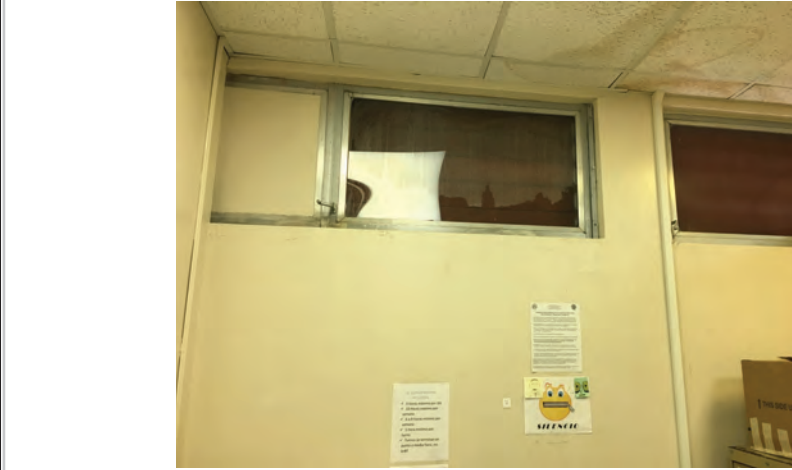
**Photo#** 10

**Damage Description:** Saturated acoustic ceiling tile

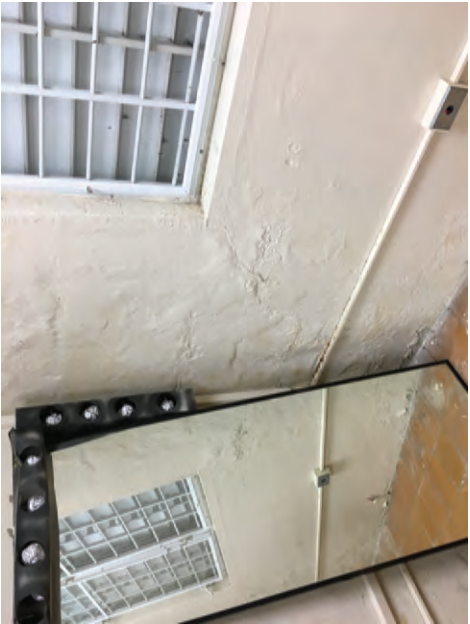
<b>Damage Description:</b> Closer view of plaster wall blister and peeling.	<b>Photo#</b> 11

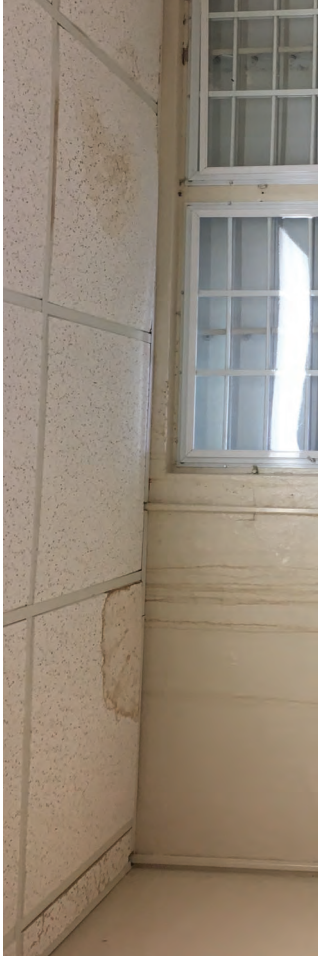
<b>Photo#</b> 12
<b>Damage Description:</b> Acoustic tiles wet, stained and sagging from water intrusion.

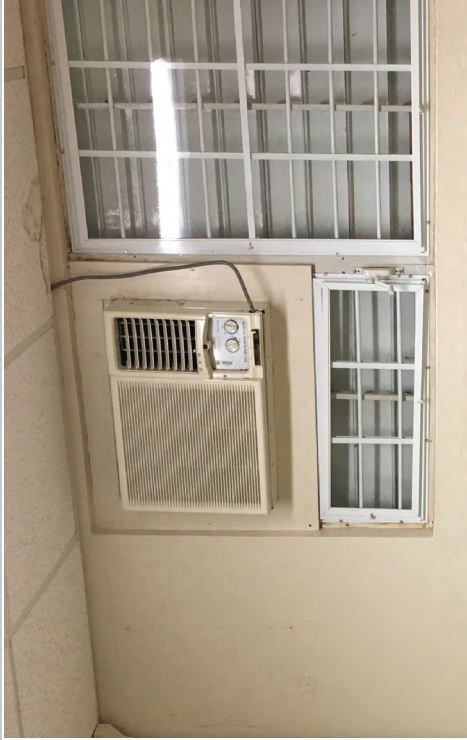
<b>Damage Description:</b> AC window unit reported as not functioning. Also note water stains on acoustic ceiling.	<b>Photo#</b> 14

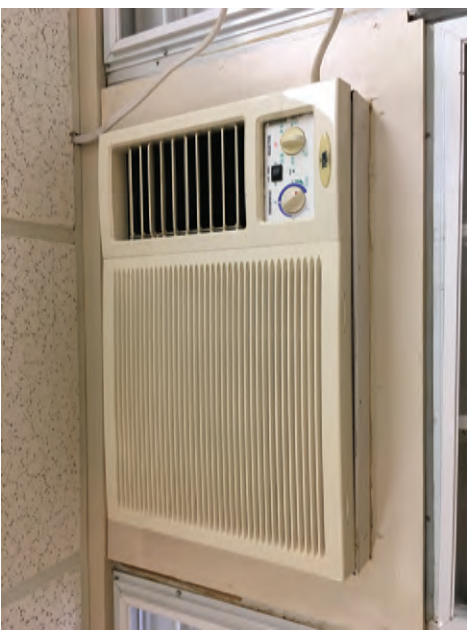
<b>Damage Description:</b> AC window unit reported as not functioning.	<b>Photo#</b> 15

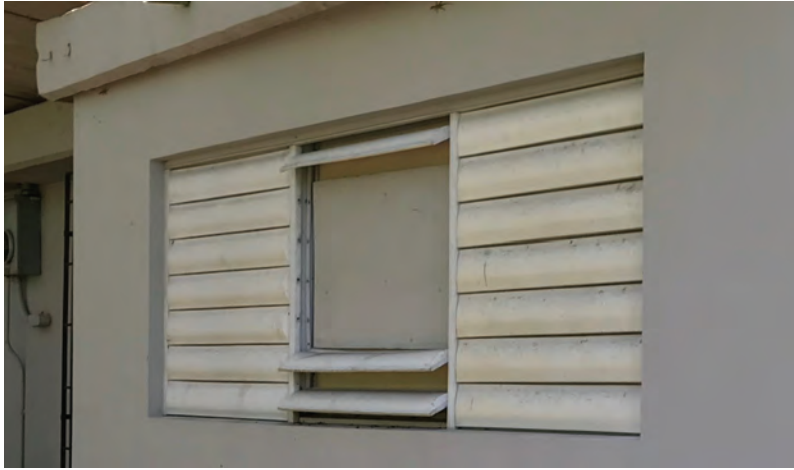
**Damage Description** **Photo#** 10  
 Wood louvers damaged (2 louvers on right window & 1 on 4th window from right)

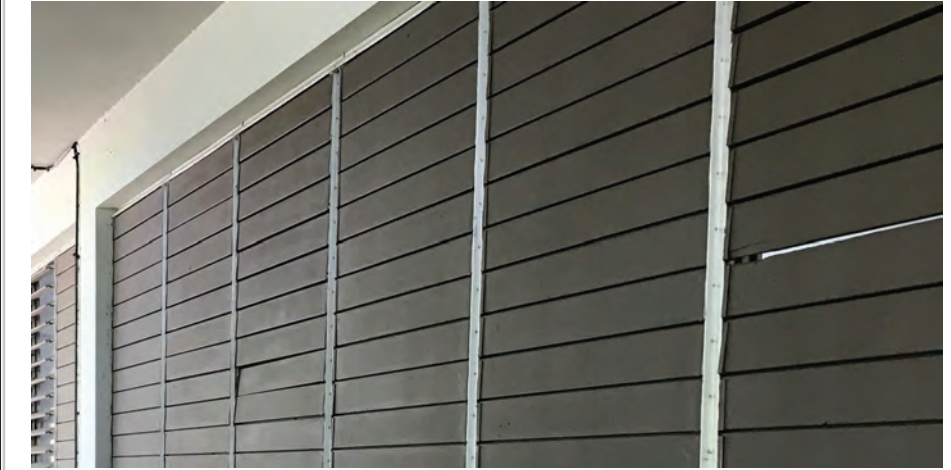
**Damage Description:** **Photo#** 11  
 Wood louver damaged (additional location) from inside view.

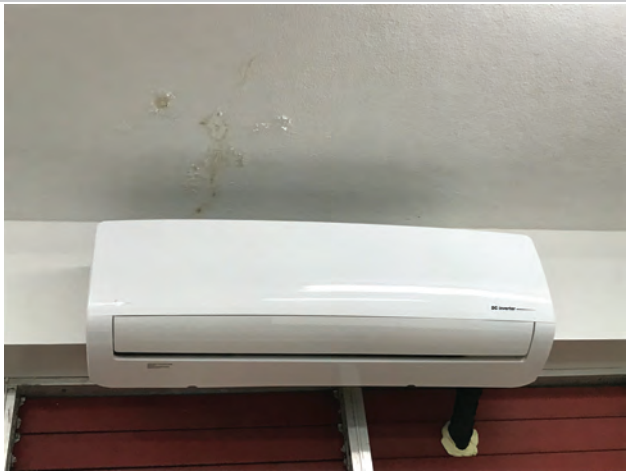
<b>Damage Description:</b>	<b>Photo#</b> 15
Ceiling plaster paint blisters and peeling

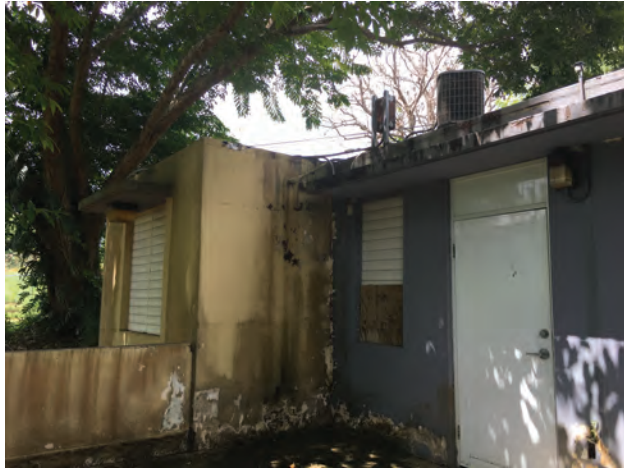
**Damage Description** Photo# 6  
Exterior walls stained and molded from water overflow from roof.

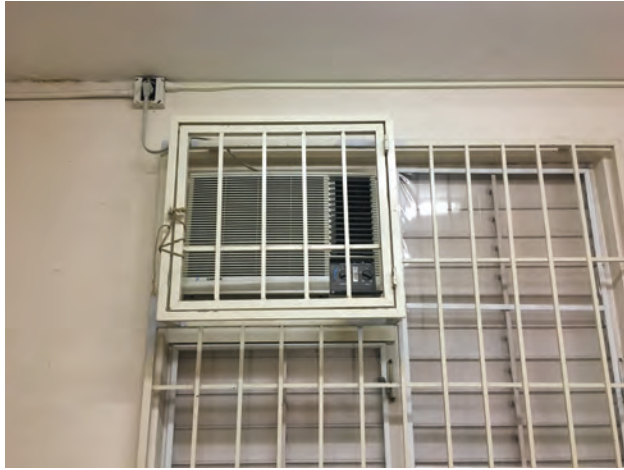
**Damage Description** AC, window unit reported as not functioning. **Photo#** 14

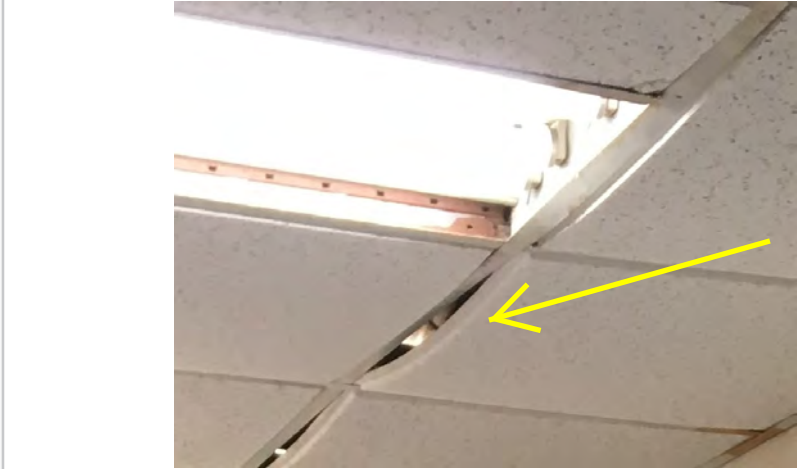
<b>Damage Description:</b>	<b>Photo#</b> 11
Building interior Fluorescent Lighting Fixture: inoperable due to water infiltration and voltage fluctuation.

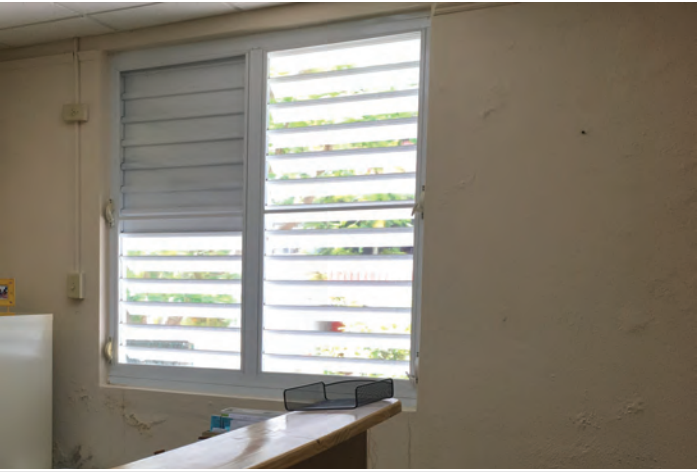
**Damage Description:** **Photo#** 11  
 Detail view of leak and paint damage (Ref; Photo# 10).

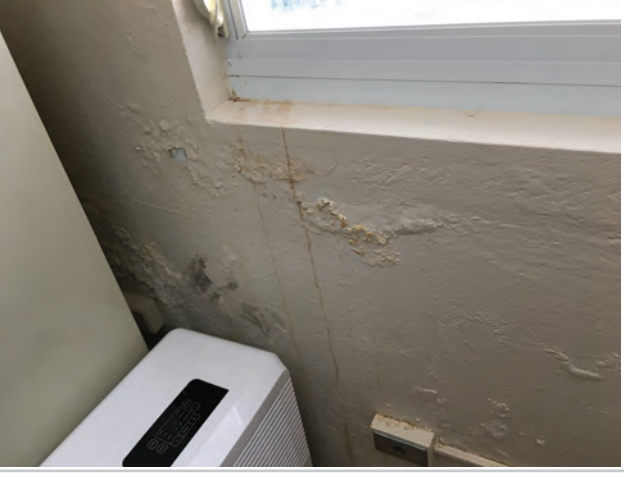
**Damage Description** **Photo#** 12  
 Wall paint blistered
