UNIVERSITY OF PUERTO RICO  
CENTRAL ADMINISTRATION  
NOTICE OF REQUEST FOR PROPOSAL RFP #DRO 24-001-3  
DESIGN AND SUPERVISION SERVICES

**DESIGN AND SUPERVISION SERVICES for  
Project Number: 008227-08264-DRO-D01-RUM**

Project Title: Reconditioning of 15 buildings and structures at  
the University of Puerto Rico Mayaguez Campus

RFP #DRO 24-001-3 / 08227 - 08264

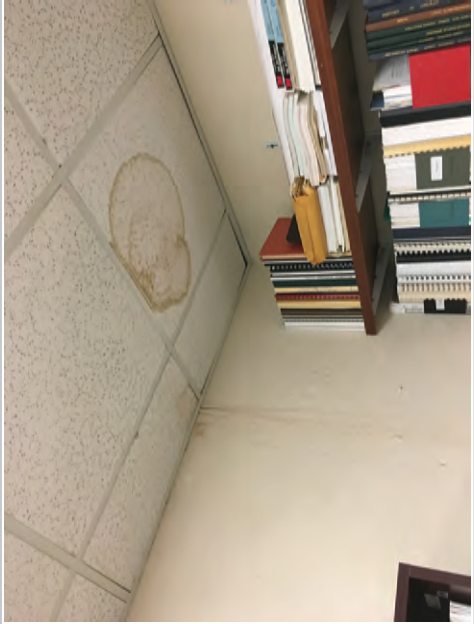
<b>Damage Description:</b> Acoustic ceiling wet and stained	<b>Photo#</b> 17

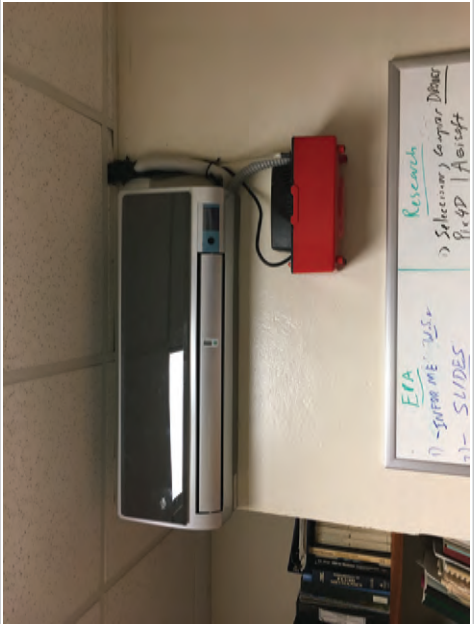
<b>Damage Description:</b> AC split unit reported as not functioning.	<b>Photo#</b> 19

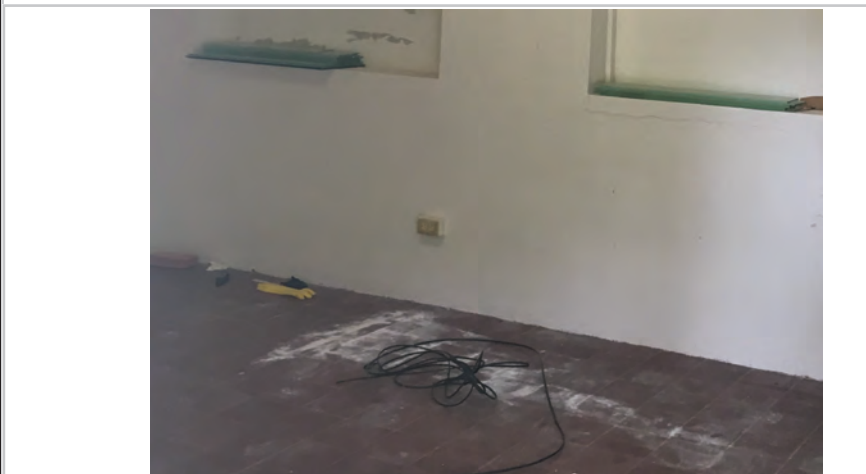
**Photo#** 8

**Damage Description** Stained quarry tile from water intrusion.

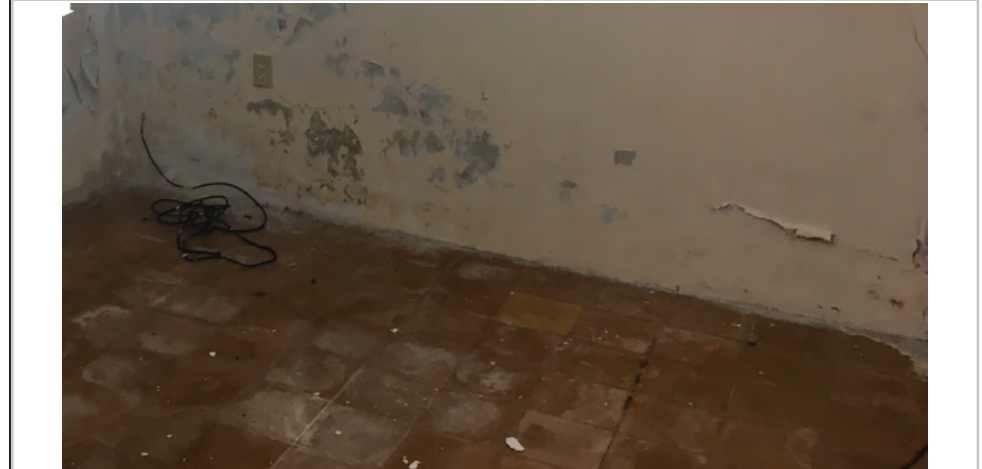
**Damage Description** Photo# 12  
 Quarry tile and plaster damage from water intrusion.

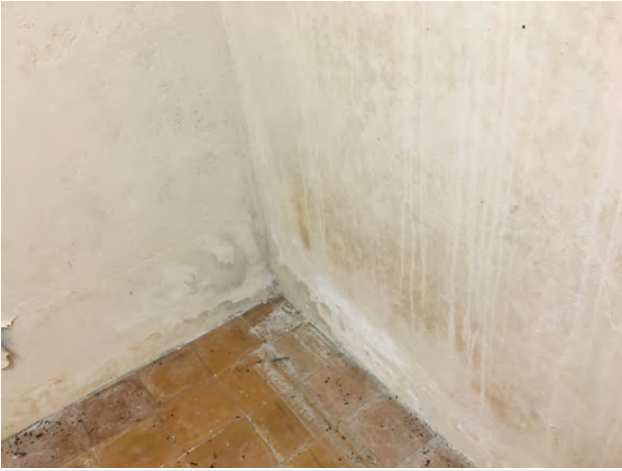
**Damage Description:** **Photo#** 13

Plaster damage from water intrusion (note water streaks). Quarry tile stained from water intrusion.

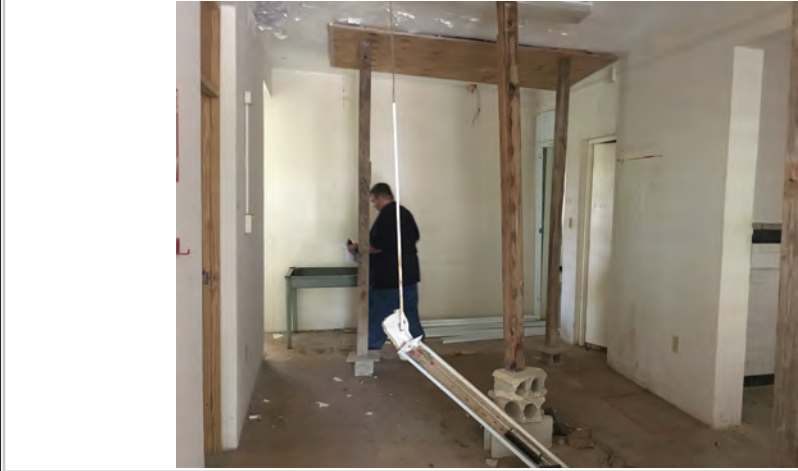
**Damage Description** **Photo#** 14

Ceiling plaster damage, 1x4 fluorescent light hanging and soiled quarry tile flooring. Beginning with this photo, photos doc

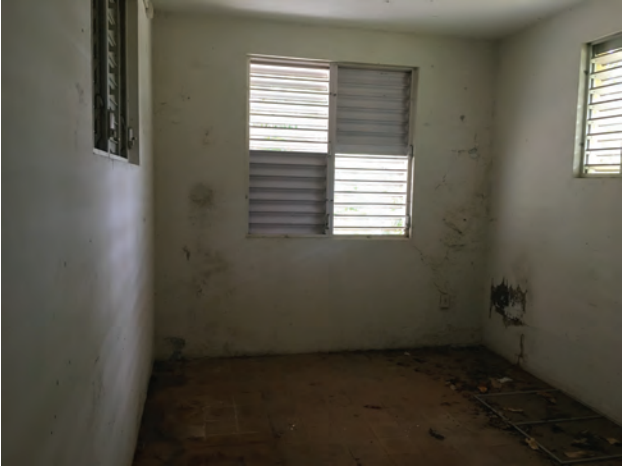
**Damage Description:** **Photo#** 17  
 Wall plaster peeling and blistered. Quarry tile stained and soiled from water intrusion.

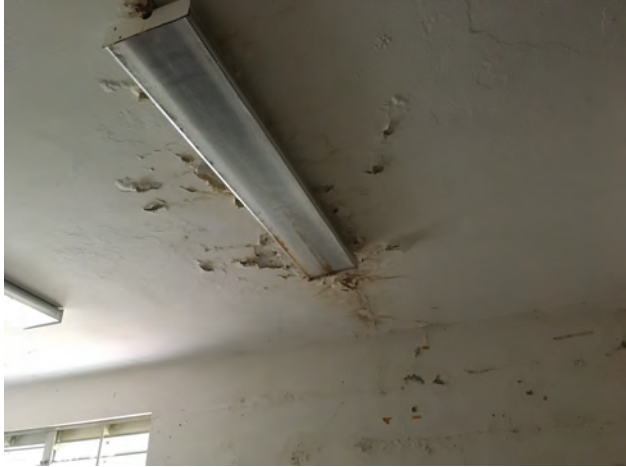
**Damage Description** **Photo#** 18  
 1x4 fluorescent light rusted from water exposure. Paint peeling and blistered from water intrusion.

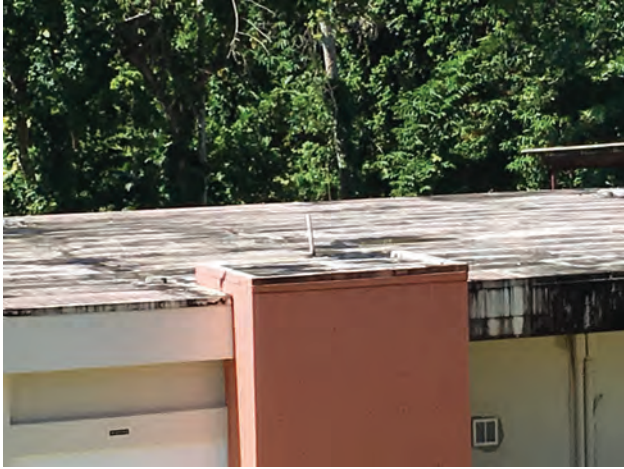
**Damage Description** **Photo#** 8

Bituminous membrane roof system loose and leaking.

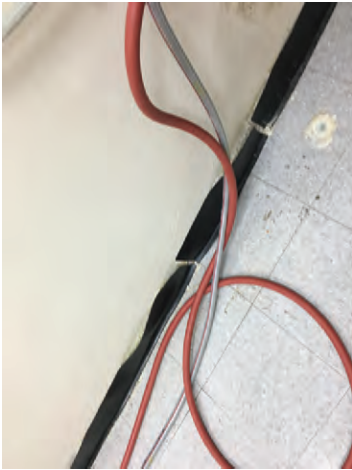
**Photo#** 10

**Damage Description** 4 IN vinyl base loose

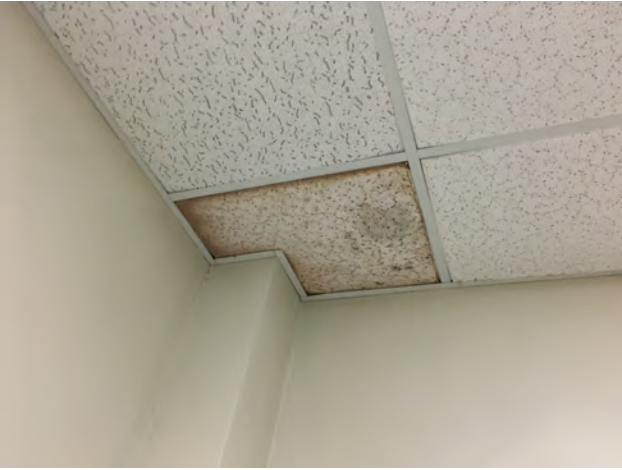
**Photo#** 12

**Damage Description** Acoustic ceiling tile molded and stained.

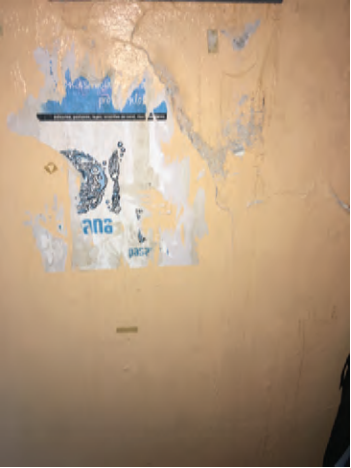
**Photo#** 7

**Damage Description:** Plaster blistered and peeling

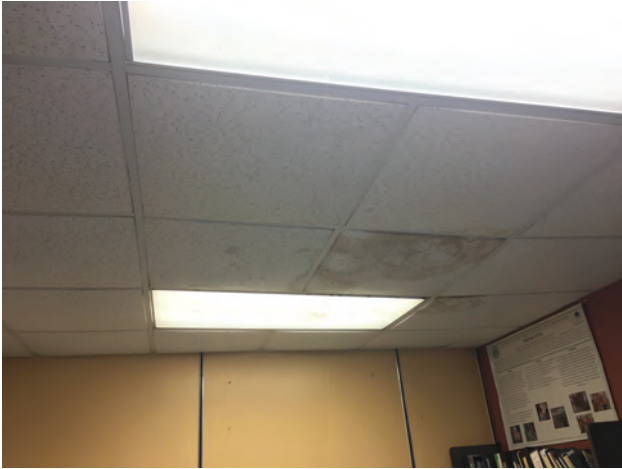
**Photo#** 10

**Damage Description** Sagging and stained acoustic ceiling tile

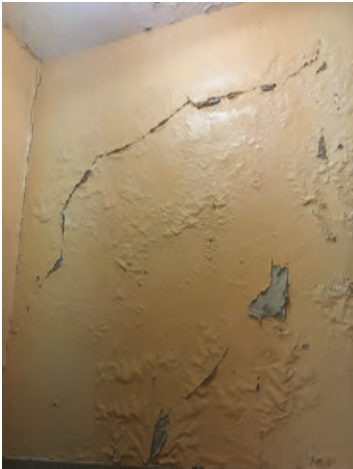
<b>Damage Description:</b> Blistered and peeling concrete plaster	<b>Photo#</b> 13

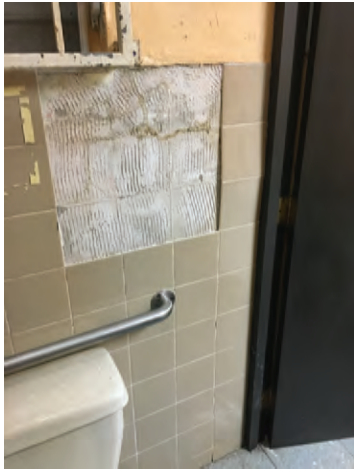
<b>Damage Description</b> Ceramic tile missing	<b>Photo#</b> 14

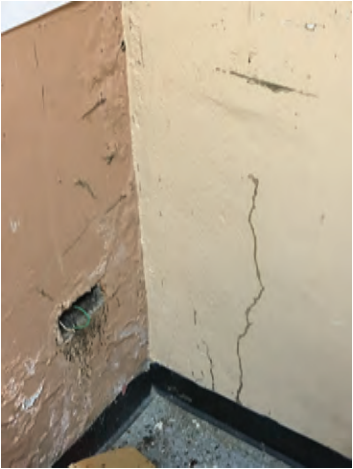
<b>Damage Description:</b> Concrete plaster blistered and peeling. Possible termite presence.	<b>Photo#</b> 15

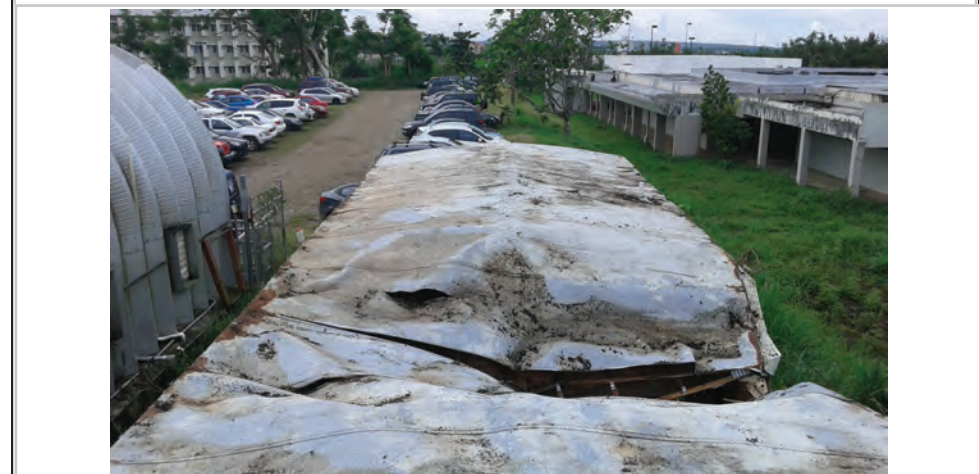
**Damage Description** Photo# 8

Roof damage after tree removed (same direction as Photo# 6). Photo supplied by UPR Mayaguez.

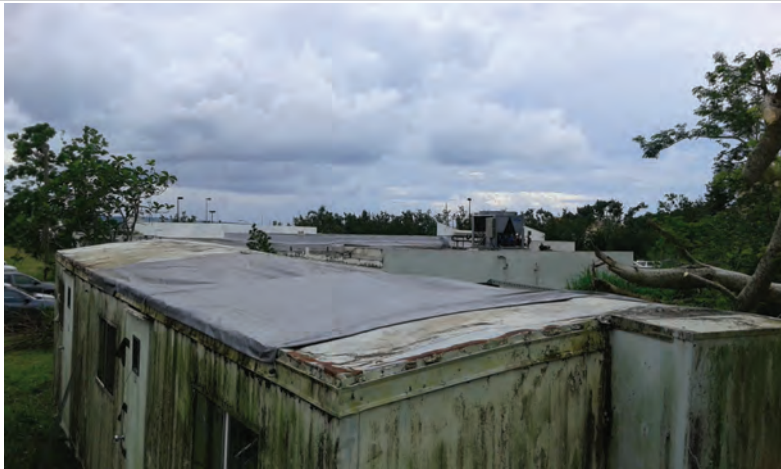
**Damage Description:** **Photo#** 11

View showing temporary repair utilizing tarp to minimize water infiltration. Photo supplied by UPR Mayaguez.

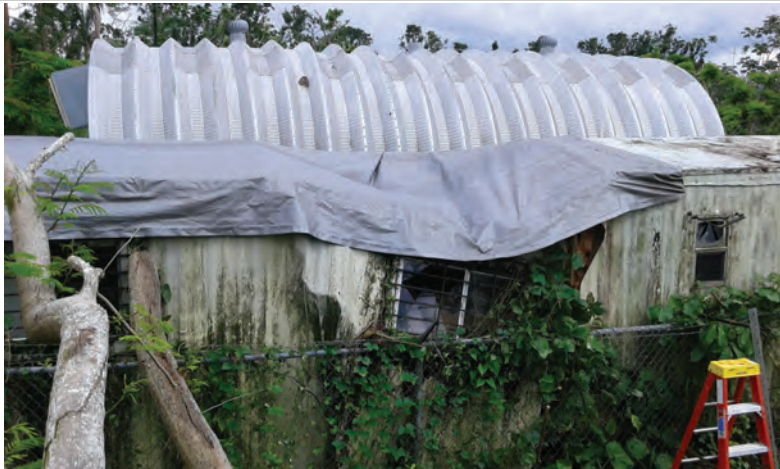
**Damage Description** **Photo#** 12

View of west elevation showing damage to the west wall structure and window. Photo supplied by UPR Mayaguez.

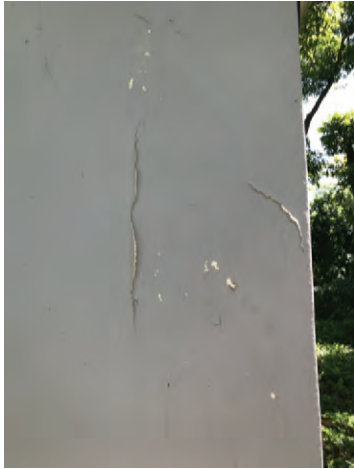
**Photo#** 6

**Damage Description:** Exterior wall plaster paint cracked and peeling

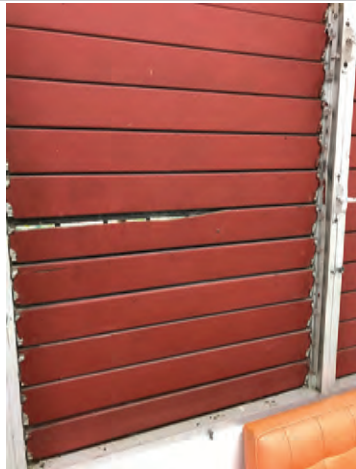
**Damage Description:** **Photo#** 11  
 Wood louver damaged (additional location) from inside view.

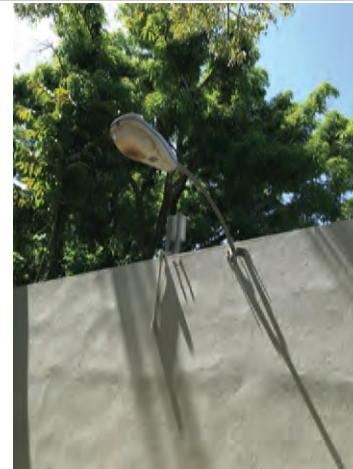
**Damage Description** **Photo#** 12  
 Exterior security light not working with water stain indicating water infiltration

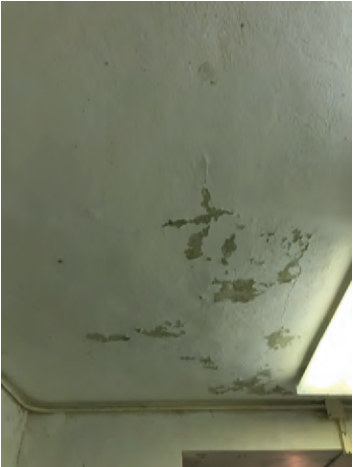
<b>Damage Description:</b>	<b>Photo#</b> 15
Ceiling plaster paint blisters and peeling

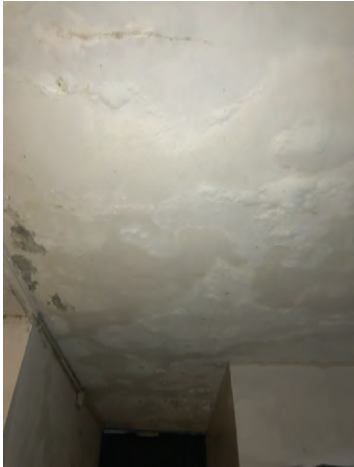
<b>Damage Description</b>	<b>Photo#</b> 16
Ceiling plaster paint blisters and peeling

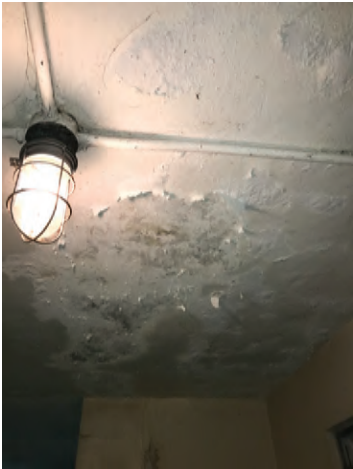
<b>Damage Description:</b> Ceiling plaster paint blisters and peeling	<b>Photo#</b> 17

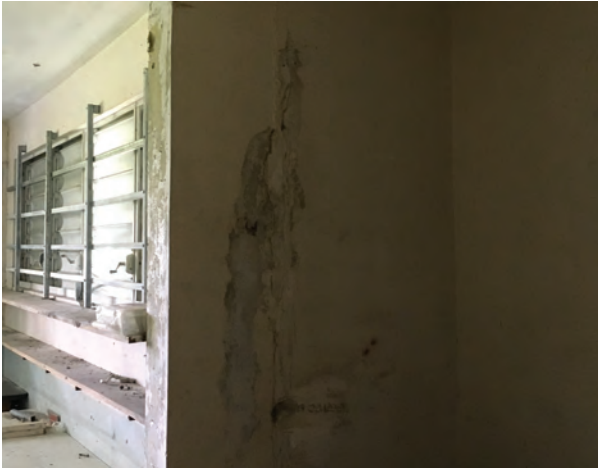
<b>Damage Description:</b> Wall painted plaster damage	<b>Photo#</b> 21

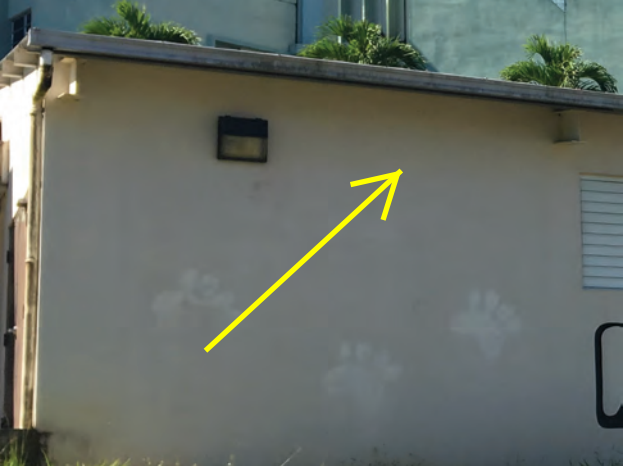
<b>Damage Description:</b>	<b>Photo#</b> 5
Building exterior Painted Surfaces: deformed, faded, and scratched due to high winds, wind driven rain, and flying debris.

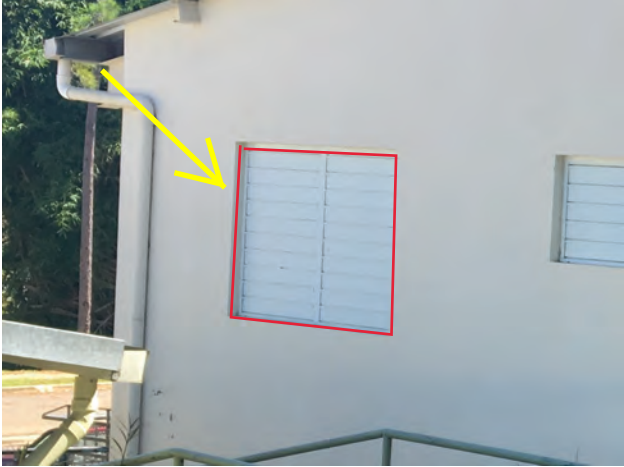
<b>Damage Description</b>	<b>Photo#</b> 6
Building exterior Aluminum Jalousie Window: deformed and broken seal gasket/caulking due to high winds, wind driven rain, and water infiltration.

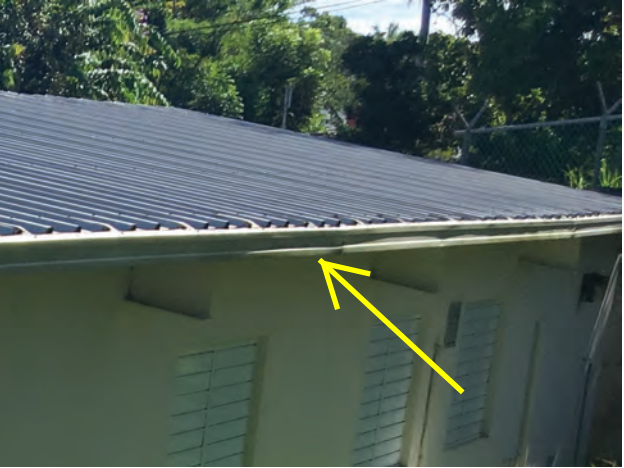
<b>Damage Description:</b>	<b>Photo#</b> 7
Building exterior Metal Gutters: deformed and misaligned due to high winds, wind driven rain, and flying debris.

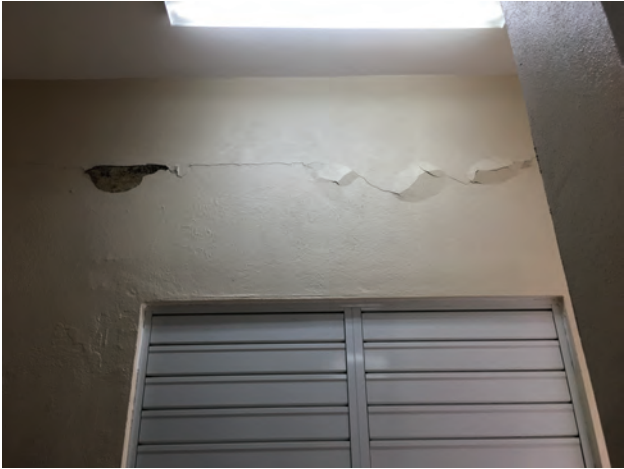
**Damage Description** Photo# 14  
Wall paint (warehouse area) peeling and cracked.

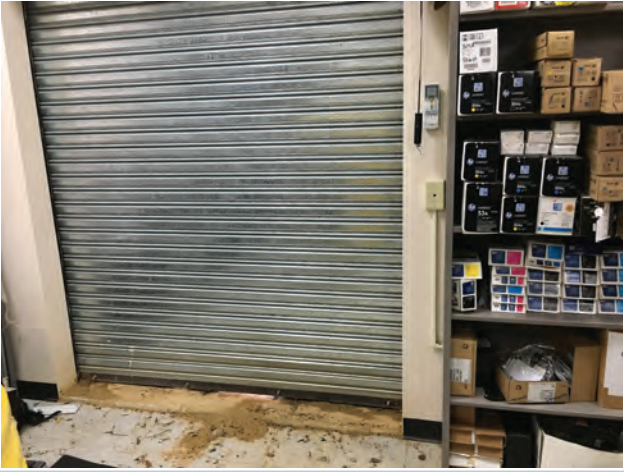
**Damage Description:** Photo# 15  
VCT floor stained from water intrusion.

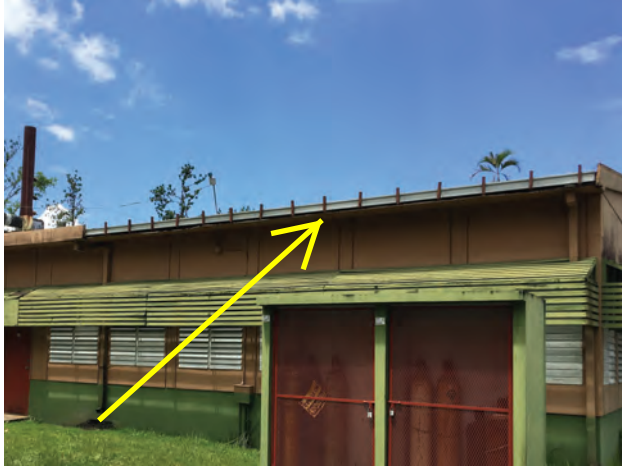
**Damage Description** **Photo#** 6

Building exterior Wood Fascia: swelling, buckling and delaminating due to high winds, wind driven rain, and flying debris.

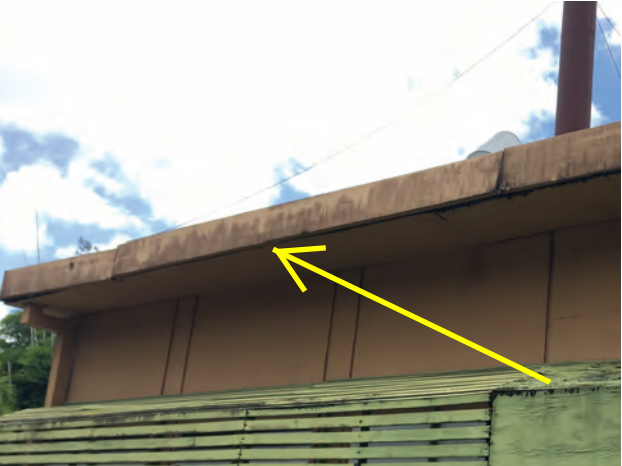
**Damage Description:** **Photo#** 7

Building exterior Wood Fascia: swelling, buckling and delaminating due to high winds, wind driven rain, and flying debris.

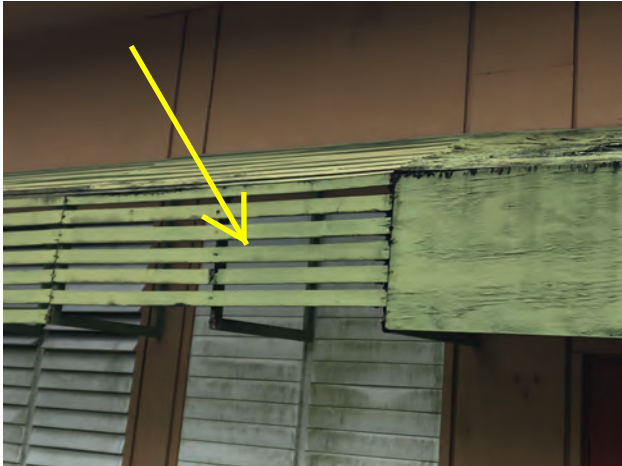
**Damage Description** **Photo#** 8

Building exterior Wood Lattice Brise Soleil (Awning): swelling, buckling and delaminating due to high winds, wind driven rain, and flying debris.

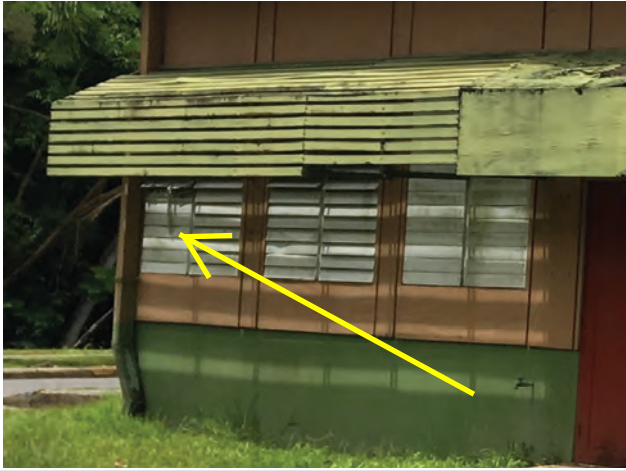
**Damage Description** **Photo#** 10

Building exterior Aluminum Jalousie Window: deformed, and inoperable due to high winds and flying debris.

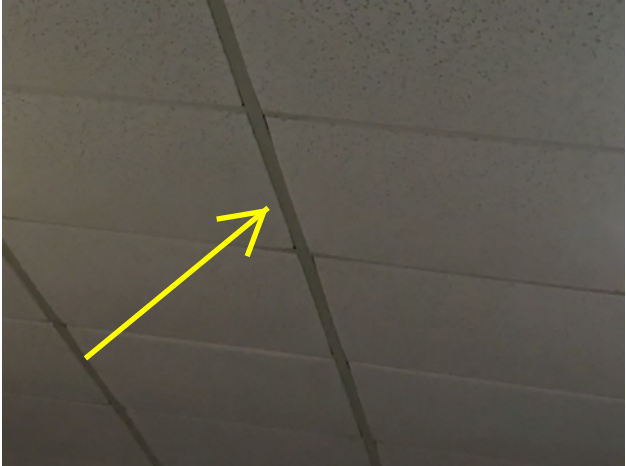
**Damage Description** **Photo#** 12

Building interior Acoustic Ceiling Tile: deformed and damped due to water infiltration.

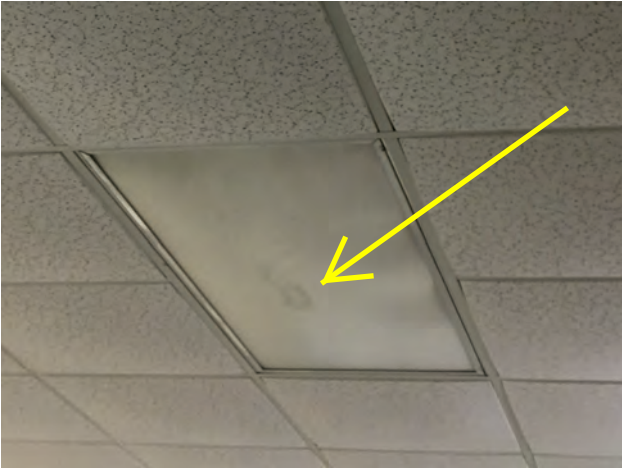
**Damage Description:** **Photo#** 13

Building interior Fluorescent Lighting Fixture: inoperable due to water infiltration and voltage fluctuation.

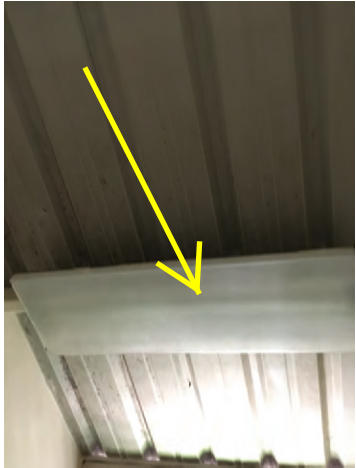
**Damage Description** **Photo#** 14

Building interior Fluorescent Lighting Fixture: inoperable due to water infiltration and voltage fluctuation.

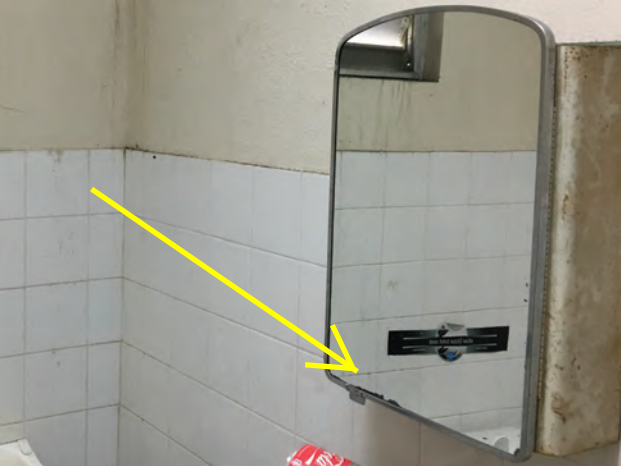
**Damage Description:** **Photo#** 15

Building interior Medicine Cabinet/Mirror: rusted, mirror rot border and broken due to water infiltration.

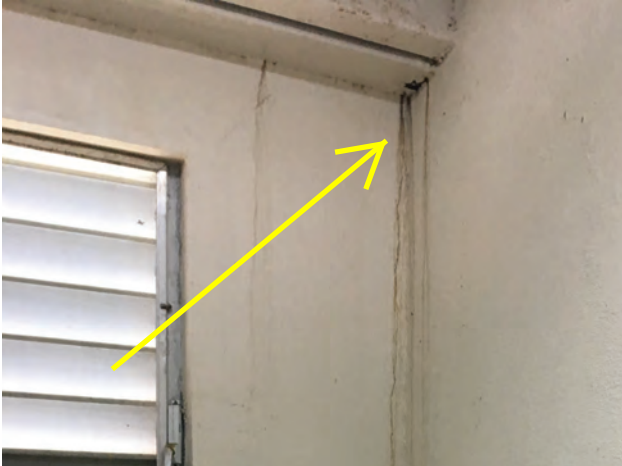
**Damage Description** **Photo#** 16

Building interior Mold Abatement: mold propagation due to water infiltration, retention, excessive humidity and a lack of A/C for an extended period of time.
